# **Navajo Abandoned Uranium Mine**

## **Site Screen Report**

### **Ramco No. 24 AUM Site**

**January 2011**

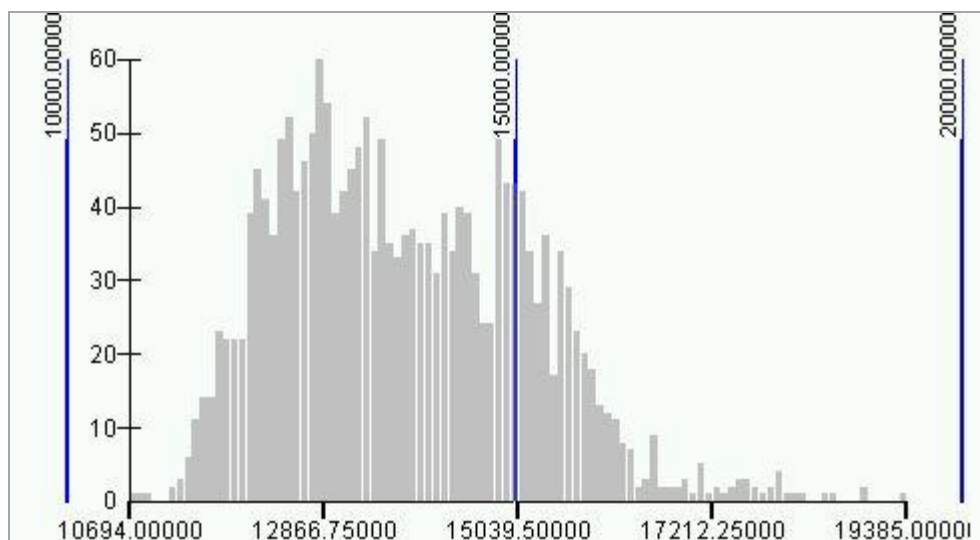
The following chart and statistics were generated by ESRI ArcGIS 9.3.1, and show the general distribution of the site gamma radiation measurements. The horizontal X axis represents the gamma radiation reading levels in cpm (lowest levels to the left). The vertical Y axis represents the frequency of each gamma radiation level.

Count:	1968
Minimum:	10694.00000
Maximum:	19385.00000
Sum:	27120773.00000
Mean:	13780.88059
Median:	13589.50000
Standard Deviation:	1370.24590

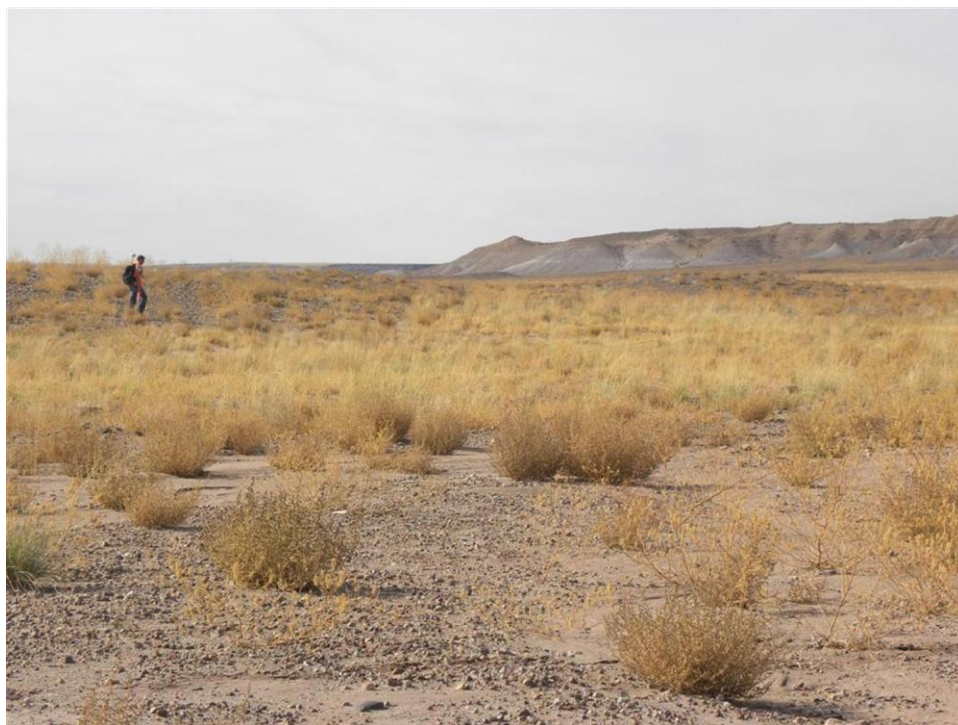
Photo 1. Ramco No. 24 mine site

Possible cap area in center of site, grey soil

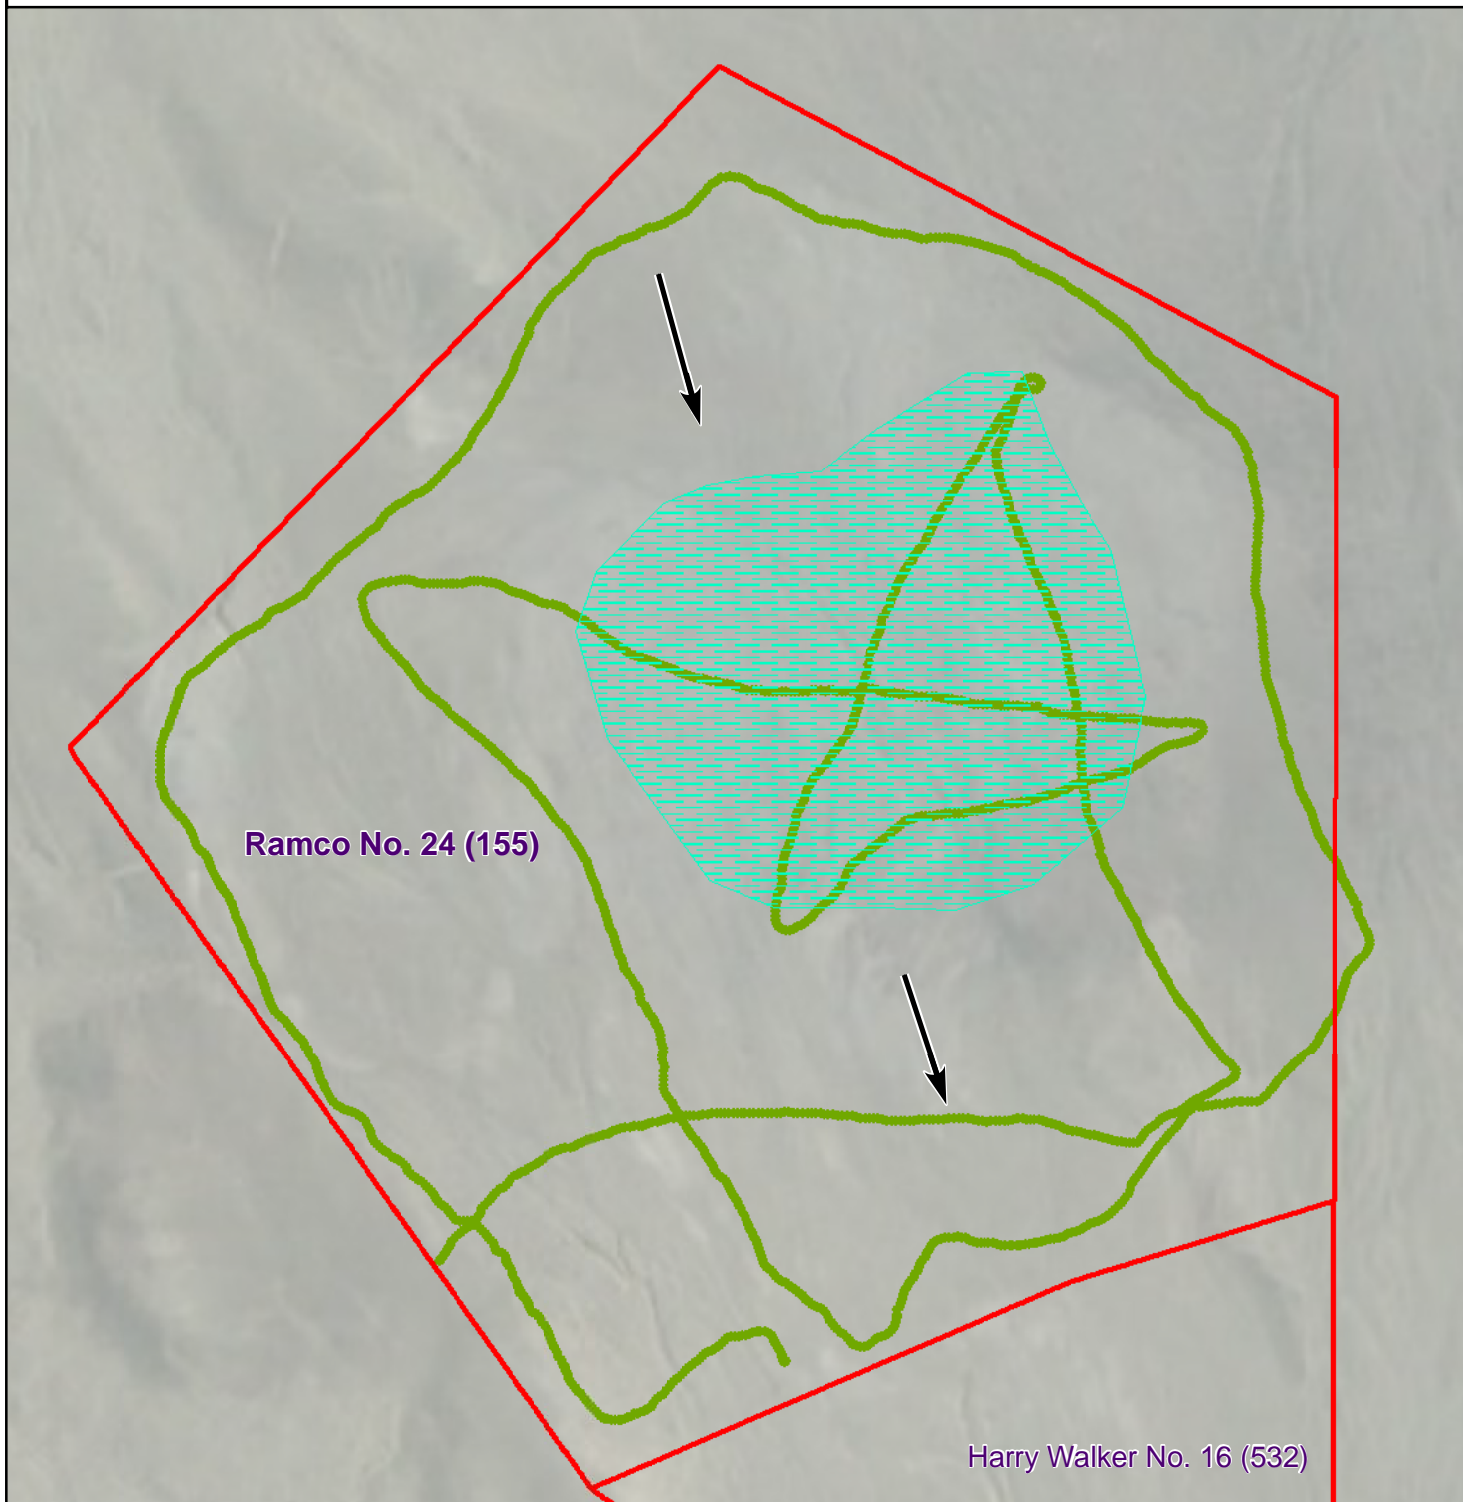
**Figure 1 - Gamma Radiation Measurements, Above Two Times Background  
Ramco No. 24 (155)  
Coalmine Mesa Chapter, Navajo Nation**

A total of 1,968 gamma radiation measurements were collected from the mine site, ranging from 10,694 cpm to 19,385 cpm. The measurements are represented in Figures 1 and 2.

Gamma survey conducted 11/2010  
Measured as counts per minute (cpm)

Average background 12,341 cpm

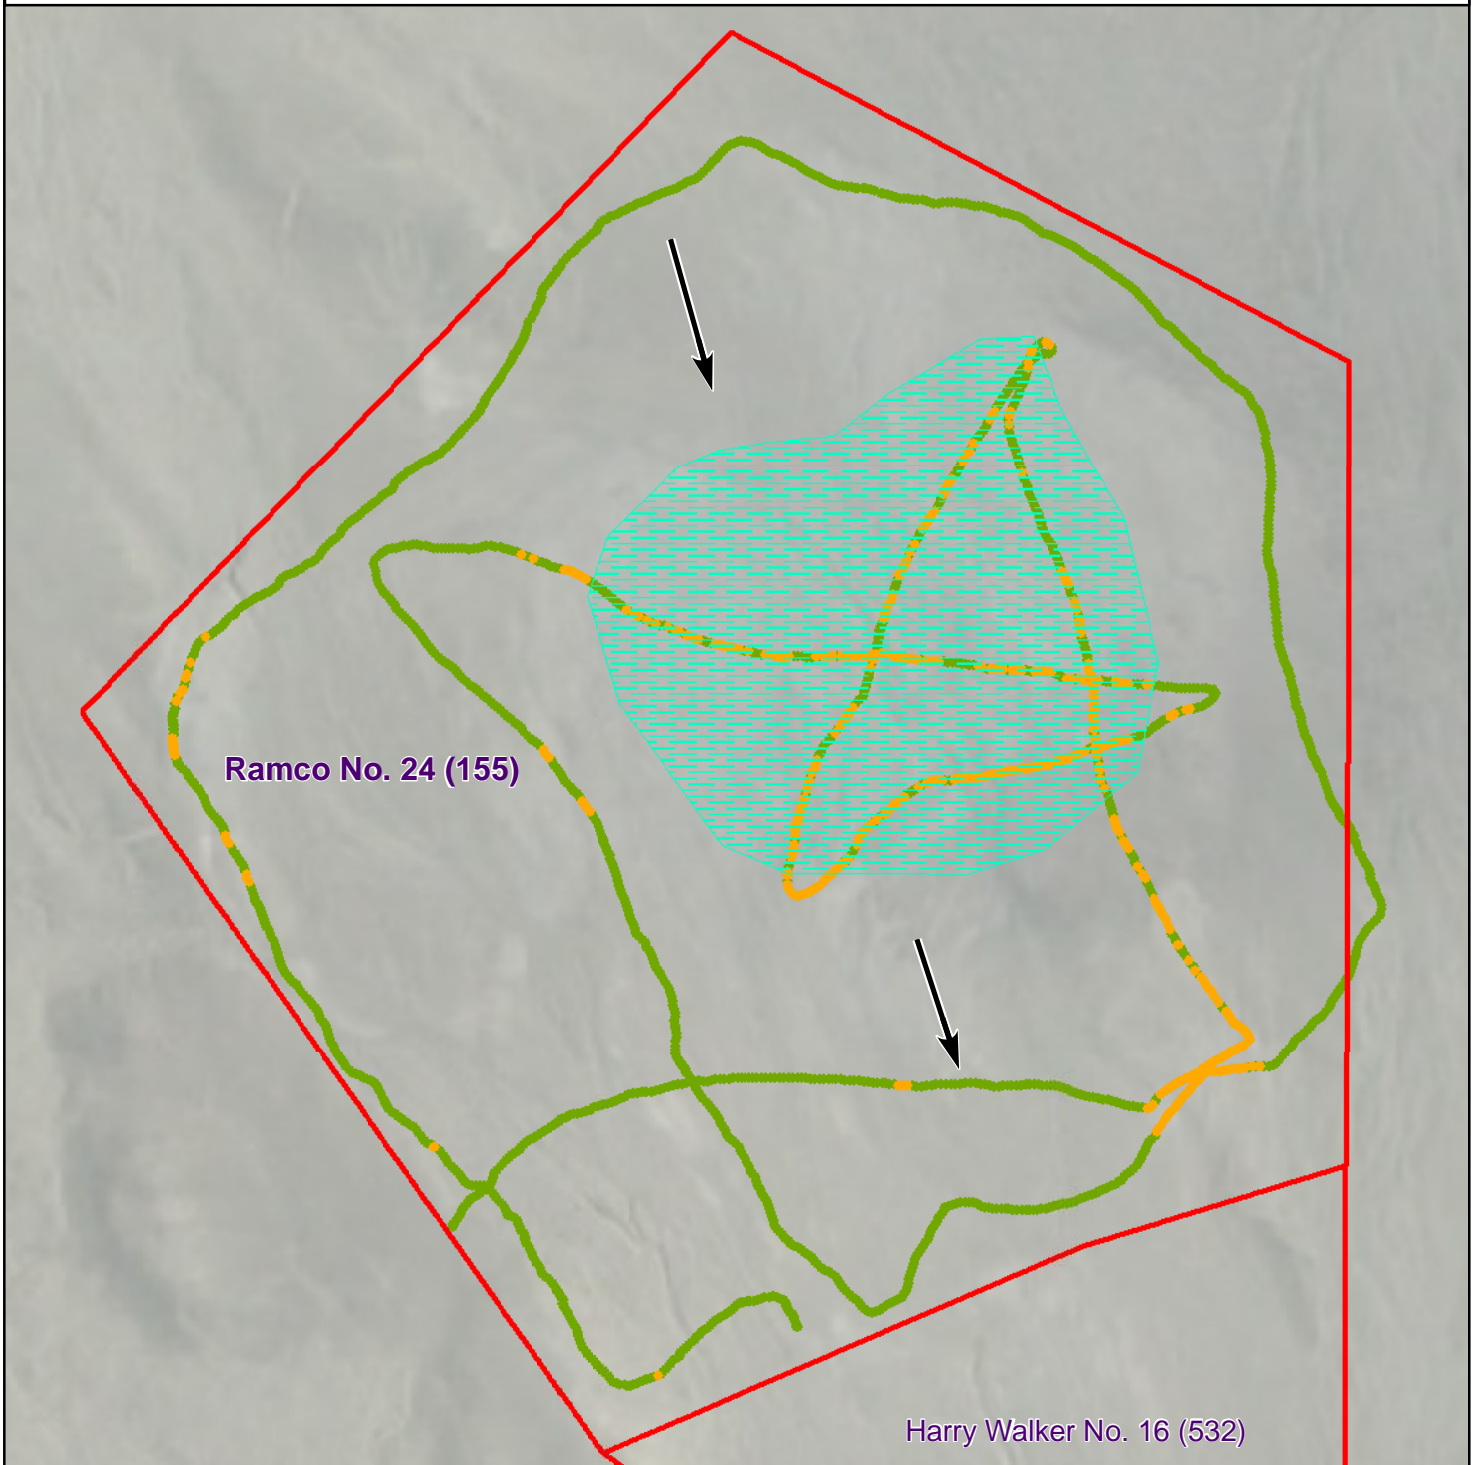
**Figure 2 - Gamma Radiation Measurements  
Ramco No. 24 (155)  
Coalmine Mesa Chapter, Navajo Nation**

**Gamma survey conducted 11/2010  
Measured as counts per minute (cpm)**

**Average background 12,341 cpm**
